Simulation of Impact Damage in a Composite Plate and Its Detection

Vitalijs Pavelko¹, Igors Pavelko¹, Maxim Smolyaninovs¹, Helge Pfeifer², Martine Wevers²

Abstract

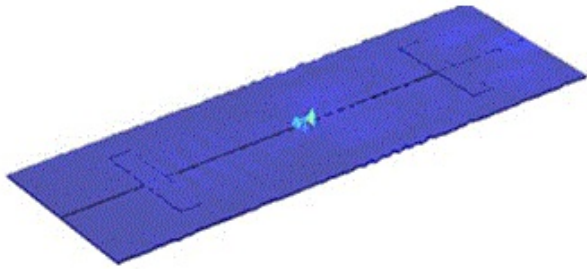
Figure 1: Simulation C-scan of a composite plate by ultrasonic method.

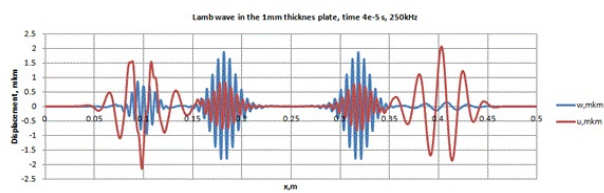
Figure 2: The guided wave (GW) interaction with damage of 1 mm composite plate (length 0.5 m).
